North Coast Regional Water Quality Control Board

Inspection Report for September 19, 2019 Warrant Inspection Humboldt County Assessor's Parcel Number 033-201-001-000

HCSO/Green Wave Humboldt County Inspections, Boris Borissov and Daniela

Borissova, CIWQS Place ID 861371

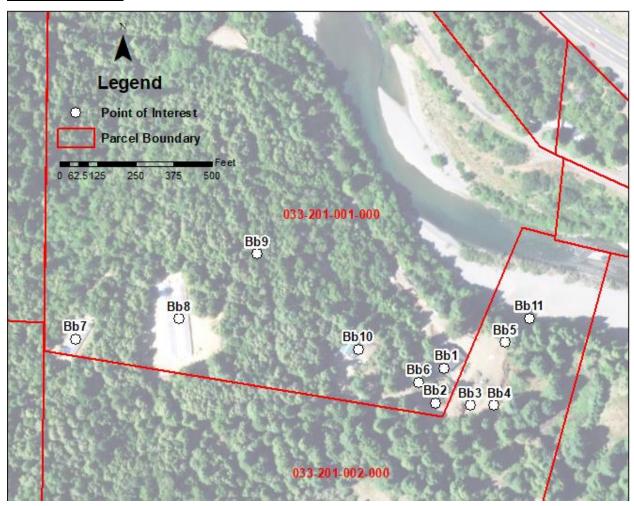
Figure 1: Property including inspection points of interest. Available parcel boundary imagery indicates that Points Bb3-5 and Bb11 are on adjacent parcel 033-201-002-000 but these features appeared to be associated with the Property

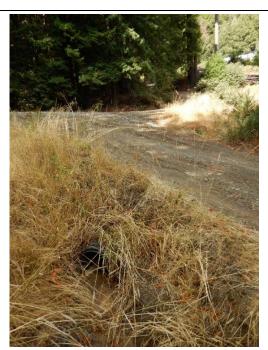
Photo 2 – Bb2; metal culvert stream crossing inlet with fine sediment accumulated upstream of inlet

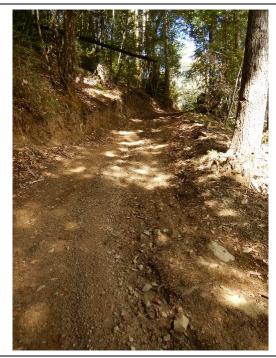
Photo 10 – Bb7; perlite, cannabis stems, and slash pushed over hillside
